Mzimkhulu
Mining

Incident Cause Analysis Method (ICAM) Report
LDV's HEAD ON COLLISION

Date: 05/02/2019

Site: Mzimkhulu Colliery

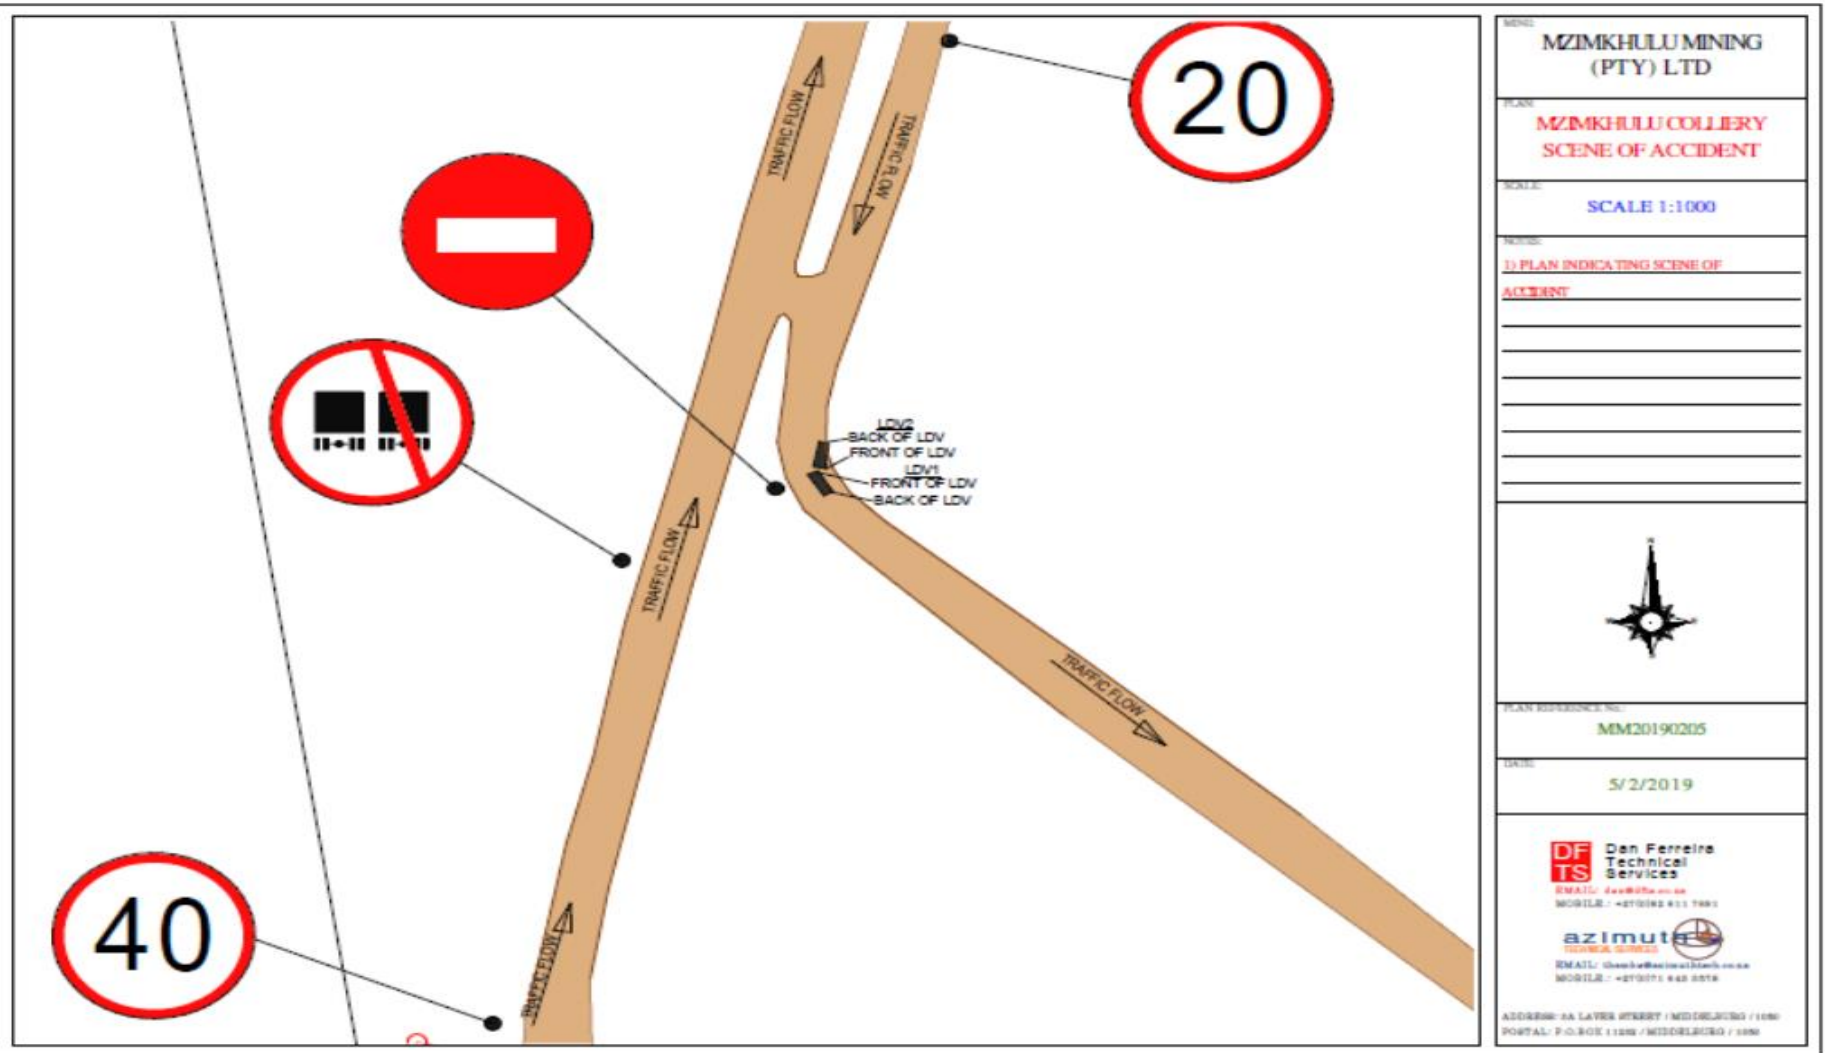
SCENE OF INCIDENT

- On 05 February 2019, at 17:55, two Diesel Power LDV's collided on the haul road towards the Diesel Power Offices.
- The Pit Superintendent was on his way to the office from the pit and the other vehicle was travelling towards the pit in a one way directional road.
- Both vehicles collided at the corner close to the brake test ramp.
- Both operators of the LDV's were speeding at the time of the incident – the speed limit in this specific zone is 20km/h.

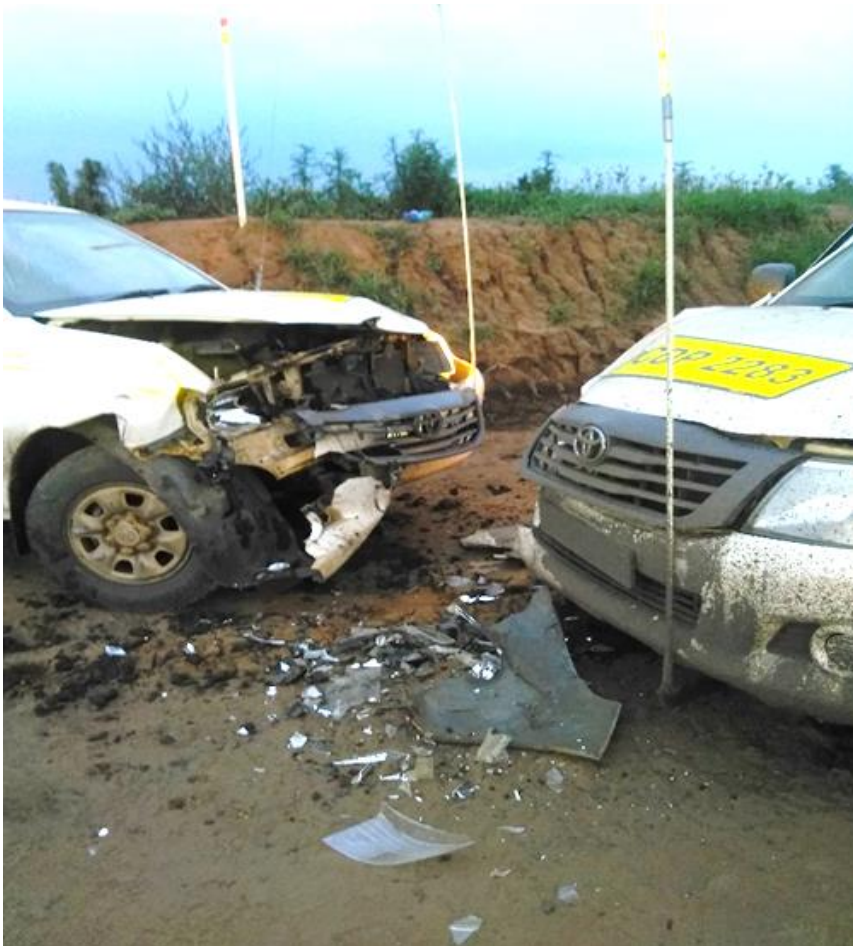
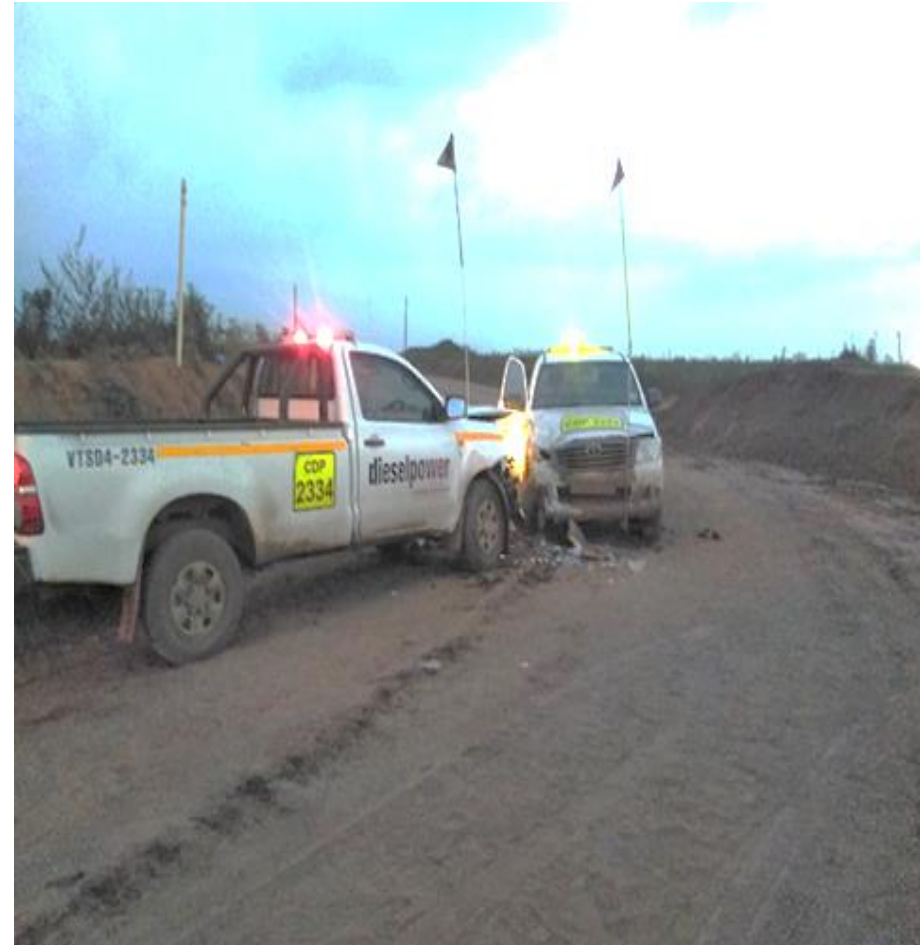
PHOTOS OF INCIDENT

Date	Time	What happened
29/01/2019		Safety Officer instructed (Inspection Report) construction supervisor to grade / maintain hard park area.
05/02/2019	10:00	Construction supervisor started tipping hard at hard park area.
05/02/2019	14:00	Pit Superintendent stated that this was the last time he visited the office / hard park area – Fatigue break
05/02/2019	17:45	Construction supervisor stated that he met J van Wyk in the pit, J van Wyk asked about the pump that was moved.
05/02/2019	17:50	Construction supervisor drives towards the offices , at the hard park he observes that the LDV road is blocked with hard loads tipped onto the road. He decided to turn around and drive back towards the pit – up the one-way. The grader operator (EM Mtetwa) stated that he did warn the construction supervisor that he is driving up a one-way, the supervisor choose to ignore him.
05/02/2019	17:55	The Pit Superintendent (J van Wyk) drives out of the Pit , up the road leading to the offices and at the corner close to the brake test ramp the LDV's made contact – head on collision. The position of the vehicles after the incident indicated that the construction supervisor did cut the corner. The speed limit in this area as per the TMP is 20km/h. From the tracking records it was clear that both LDV's were speeding: <ul style="list-style-type: none"> • Pit Superintendent was travelling at 66km/h at the point of contact. • Construction supervisor was travelling at 53km/h at the point of contact. All drivers and the passenger claimed to have used their seatbelts. Airbags on both LDV's did not deploy.

- **Change management** – Issue clear instructions.
- **Proper task planning** – LPC.
- **Adequate risk assessment** - Task specific.
 - What?, When?, **How?** and **Why?**
- **LDV compliance file**– Equivalent to HME.
 - ❖ Service records LDVs as per OEM.
 - ❖ Dynamic brake tests for LDVs.
 - ❖ Conduct regular inspections on LDVs.
- **Speed monitoring**- Download tracking events.
- **TMLP and PDS** – **Level 1-6** and PDS implementation.

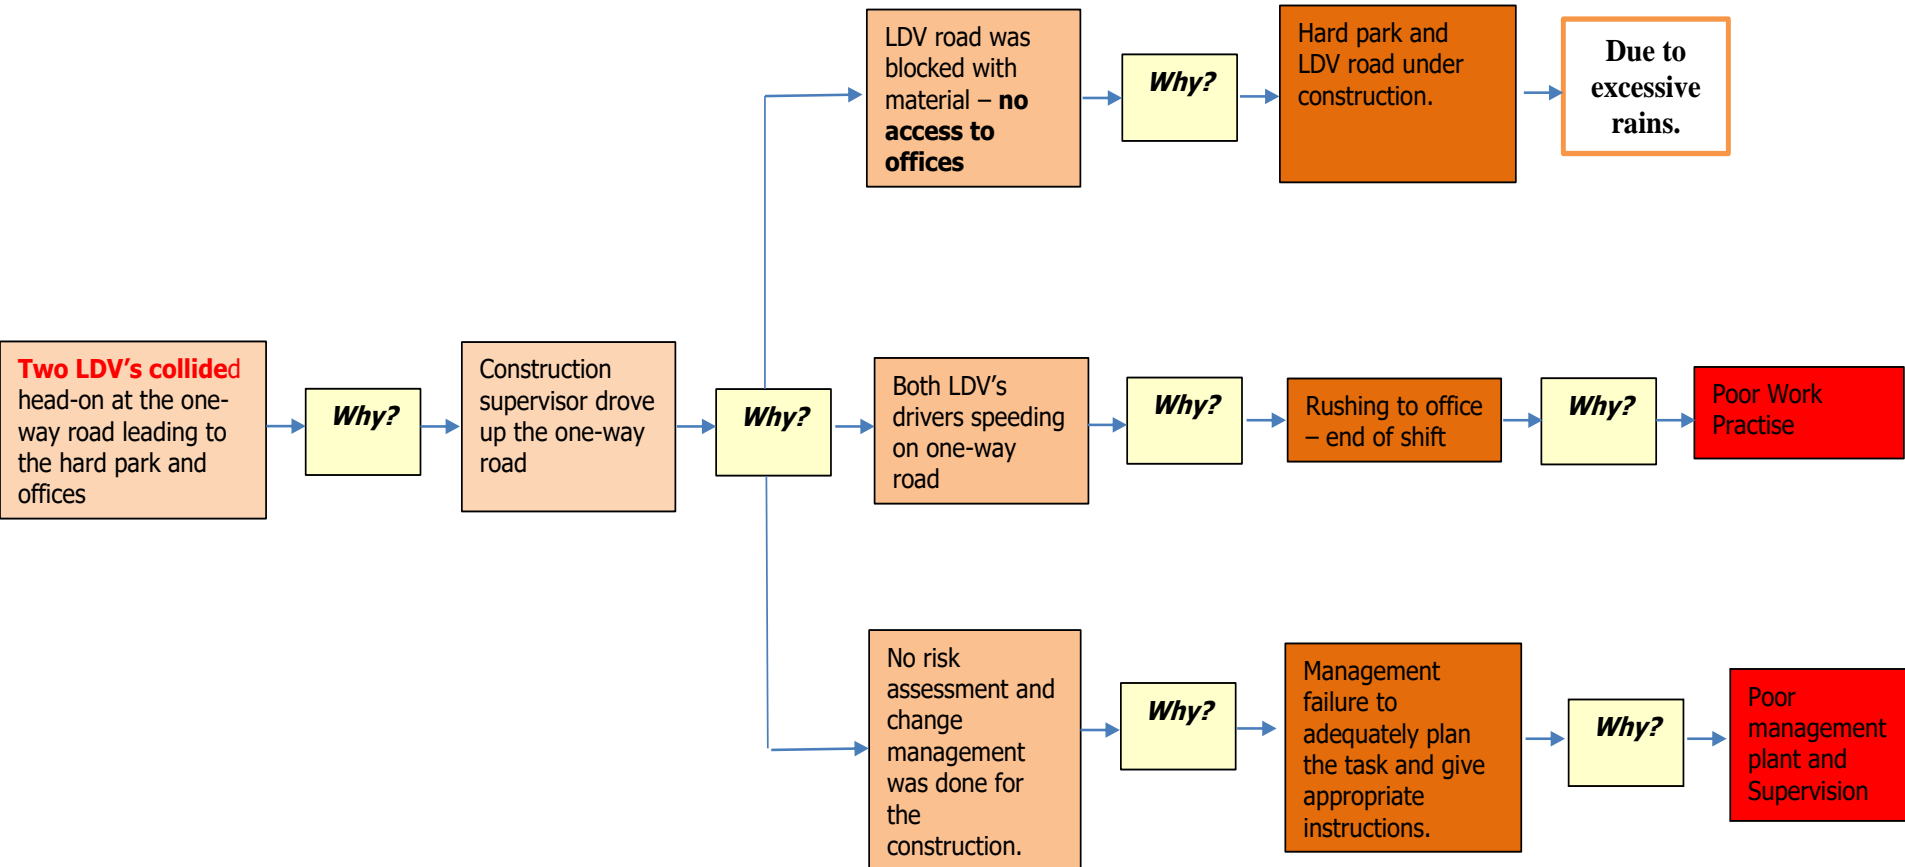
ROOT CAUSE PROCESS FLOW

- **No proper planning** for construction of the hard park.
- **No risk assessment was done** - Alternative route.
- **No change management** - Communication of changes.
- **Failure to adhere to speed limit** - Traffic Management Plan.
- **Poor judgement** – Construction supervisor driving up a one-directional road.
- **Both LDV's not equipped with PDS** as per (Reg. 8.10(2.1) & 8.10(2.1)a).
- **Substandard on equipment:**
 - ❖ No proof of service records for both LDVs.
 - ❖ No proof of dynamic brake tests for both LDVs.
 - ❖ No proof of quarterly tagging records.
