# **Appendix A**

## **Summary of Results from Field Studies**

# **MOBILE MACHINES**

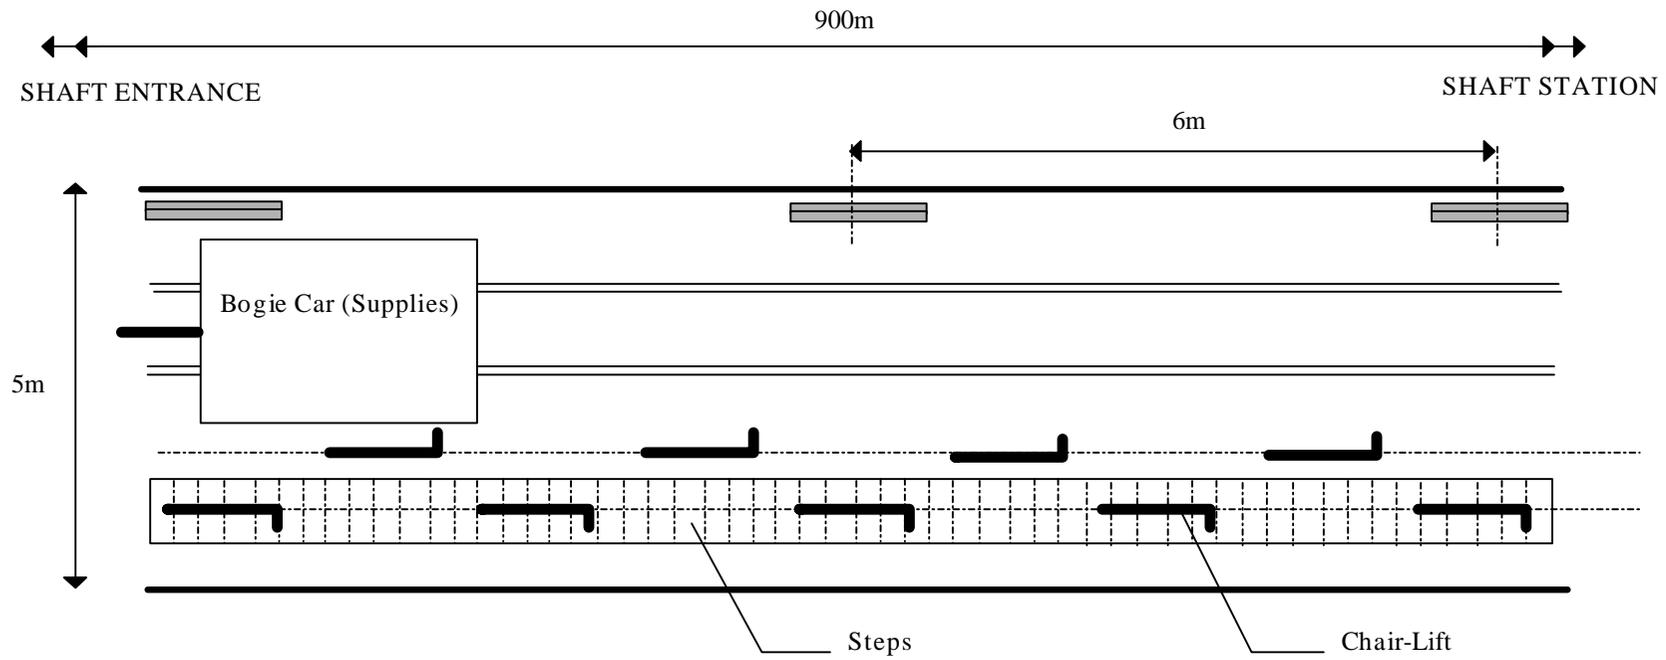
*Inclined Shaft Incorporating Chairlift*

Chairs suspended every 3 to 4 m in the centre of the stairway presented an obstruction.

Pipe ranges and other equipment mounted on shaft wall next to stairway.

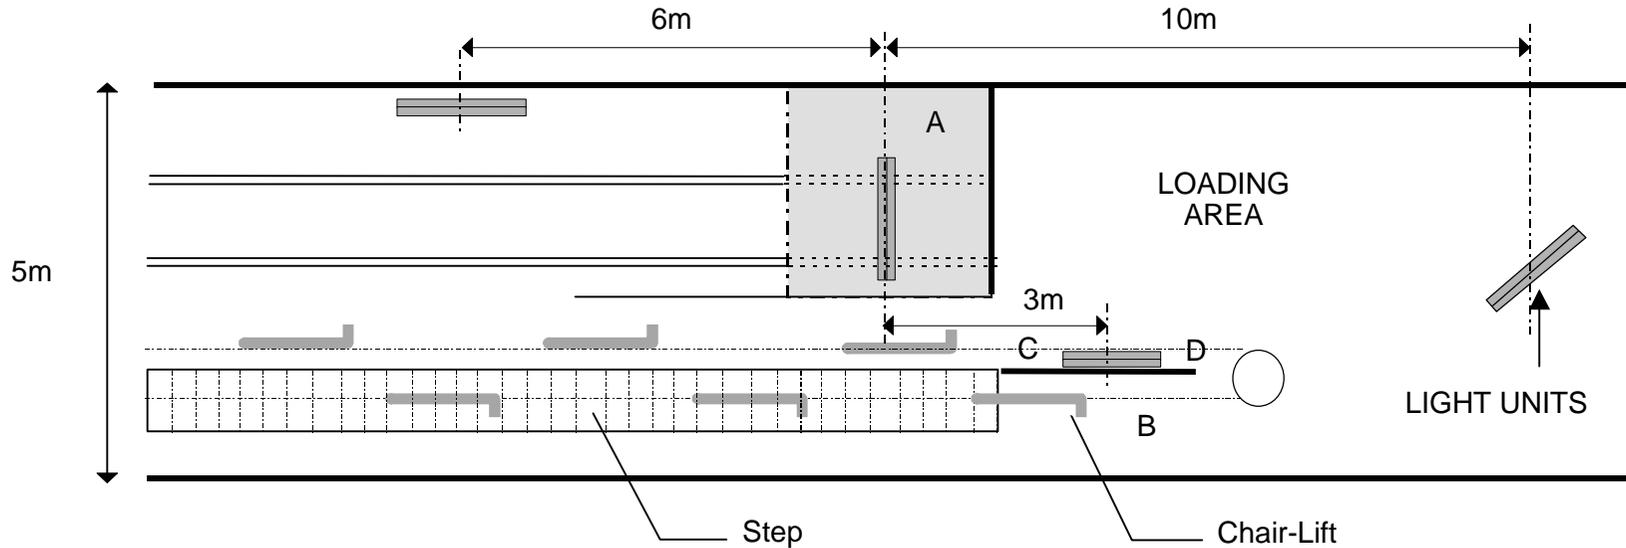
**Shaft Station at Bottom of Inclined Shaft**

The floor was generally free from obstructions, although in places it was extremely slippery from water running

down the inclined shaft. Supplies removed from the haulage were frequently stored at the sides of the loading area.

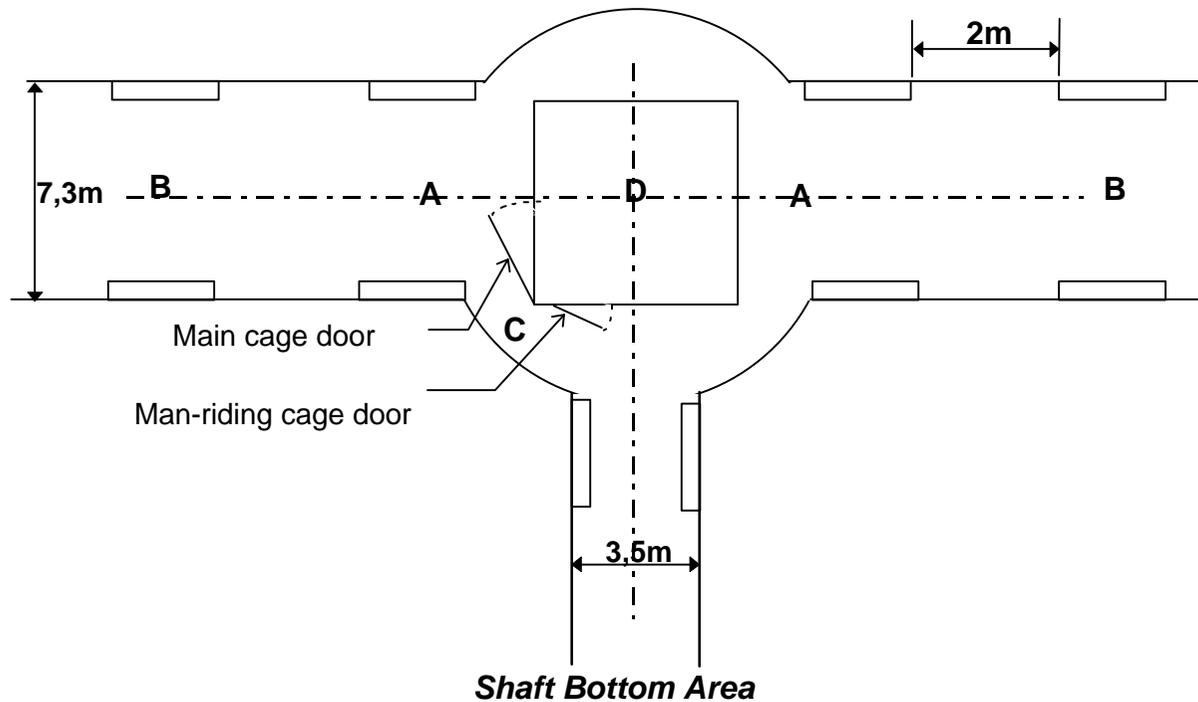
Operator opening cage door adjacent to man-riding lift unable to see men queuing, entering or leaving bottom deck of lift.

Lift operator has restricted vision of men queuing, entering, leaving bottom deck of lift.

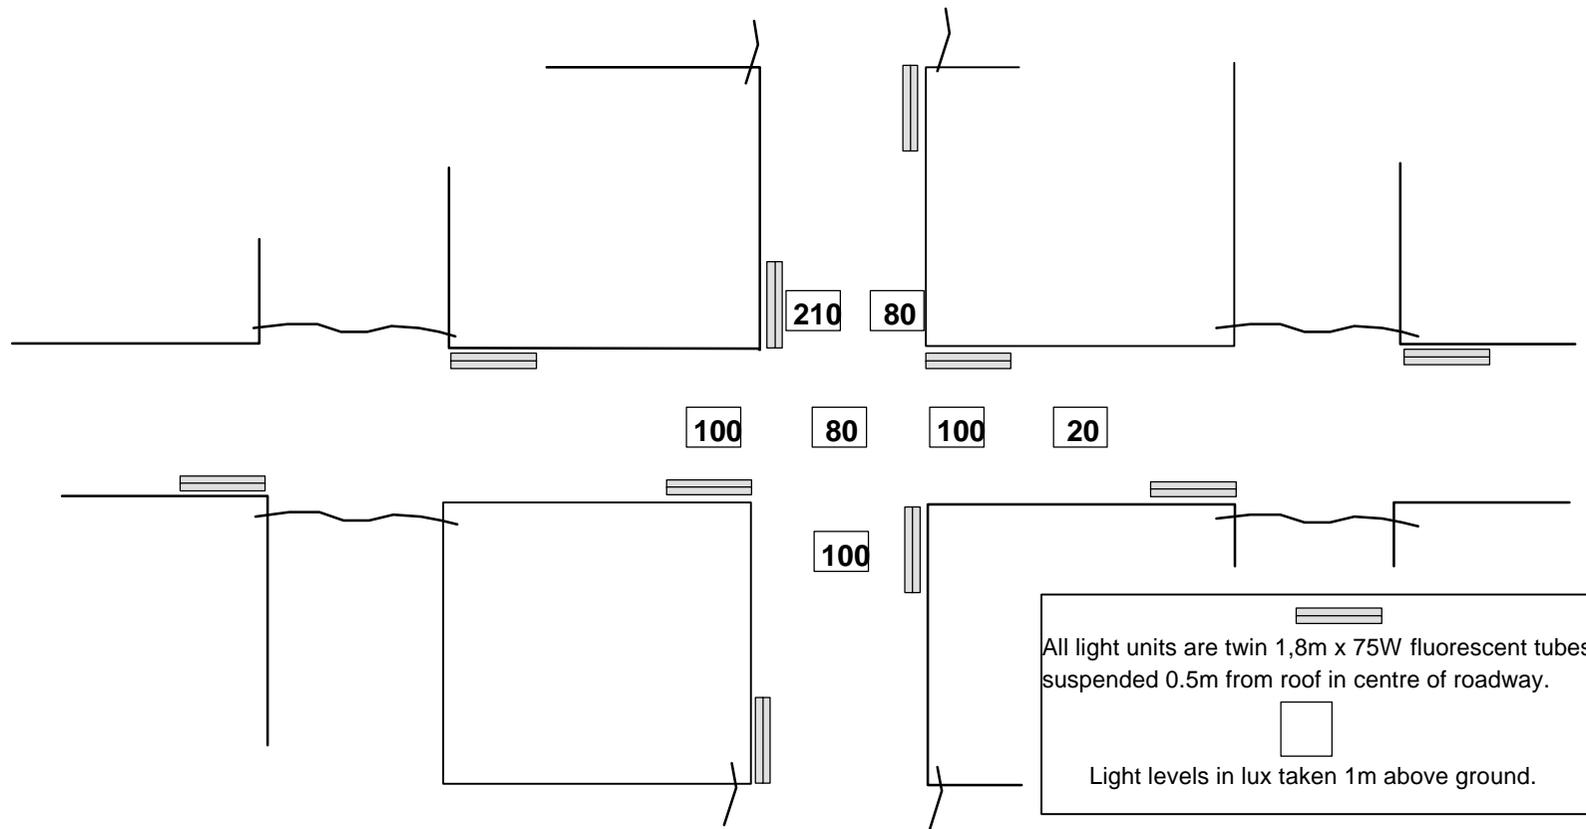
### ***Junction 2.***

Junction floor had recently been graded and was therefore level. There was some residual material floor scrapings at the sides. Prior to grading the ground had been churned up by the wheels of heavy vehicles which left ridges of loose material and loose stones.

Floor conditions in the roadways was generally firm and free from obstructions.

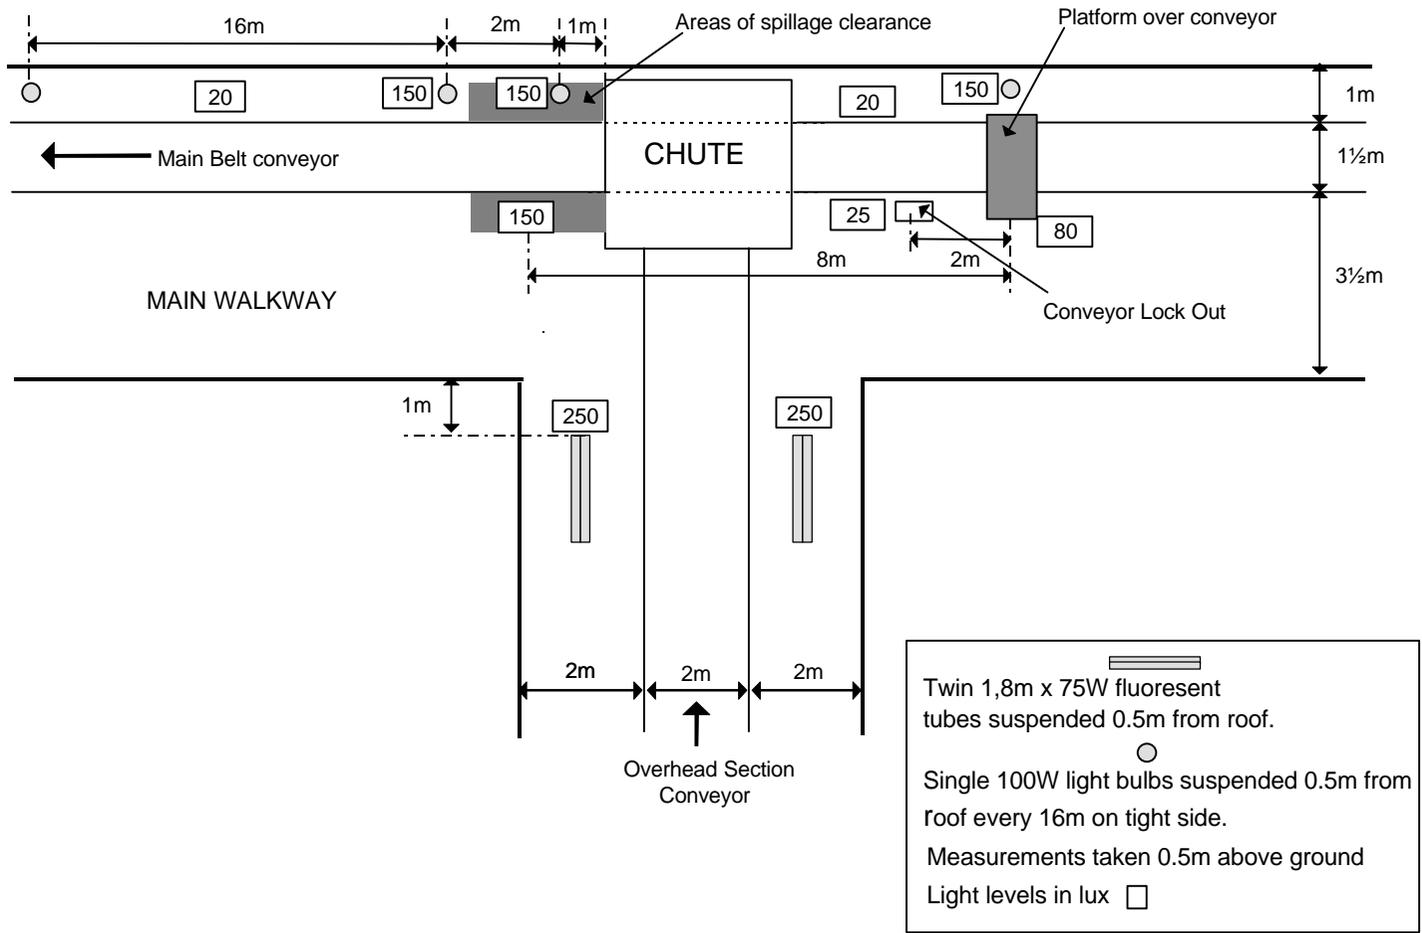
**Material Transfer Point 1.**

<b>Visual Targets:</b>	Steps, handrail and floor of platform [VT5]
<b>Operational Blind Spots:</b>	None
<b>Major Postural Changes:</b>	None.
<b>Visual Environment:</b>	
<b>Visual angle</b>	Platform structure at a range closing to 0,5m
<b>Illuminance-</b>	See values marked on diagram

<b>Reflectance-</b>	Low, platform was painted a dark colour.
<b>Contrast-</b>	Very low, steps, platform and handrails were same colour as walkway
<b>Visual conditions-</b>	Generally good, however, there was a continual presence of airborne dust from conveyor and a settling of dust on lights restricted output levels.
<b>Classification-</b>	Identification/Course tracking
<b>Operators comments-</b>	None

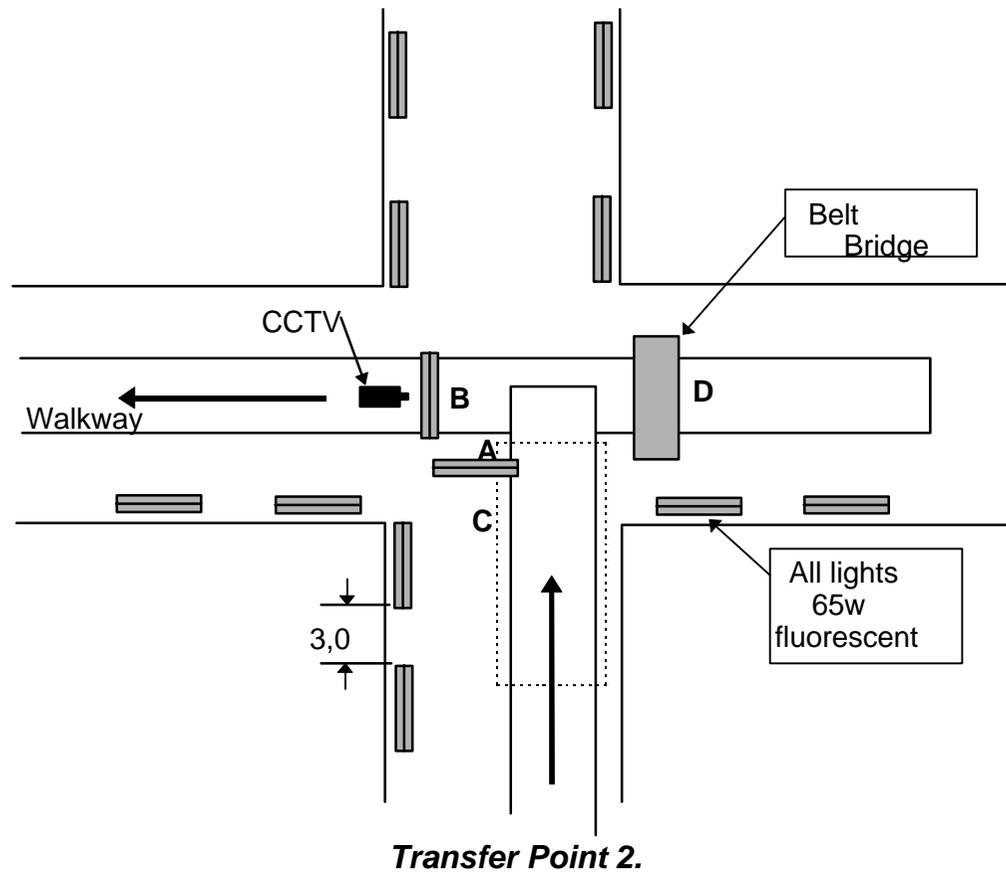
The walkway over the belt was well illuminated (160 lux). All lights in the area were working.

No visual limitations were identified that were likely to contribute to the risks arising from any of the inherent hazards that existed in the area examined.

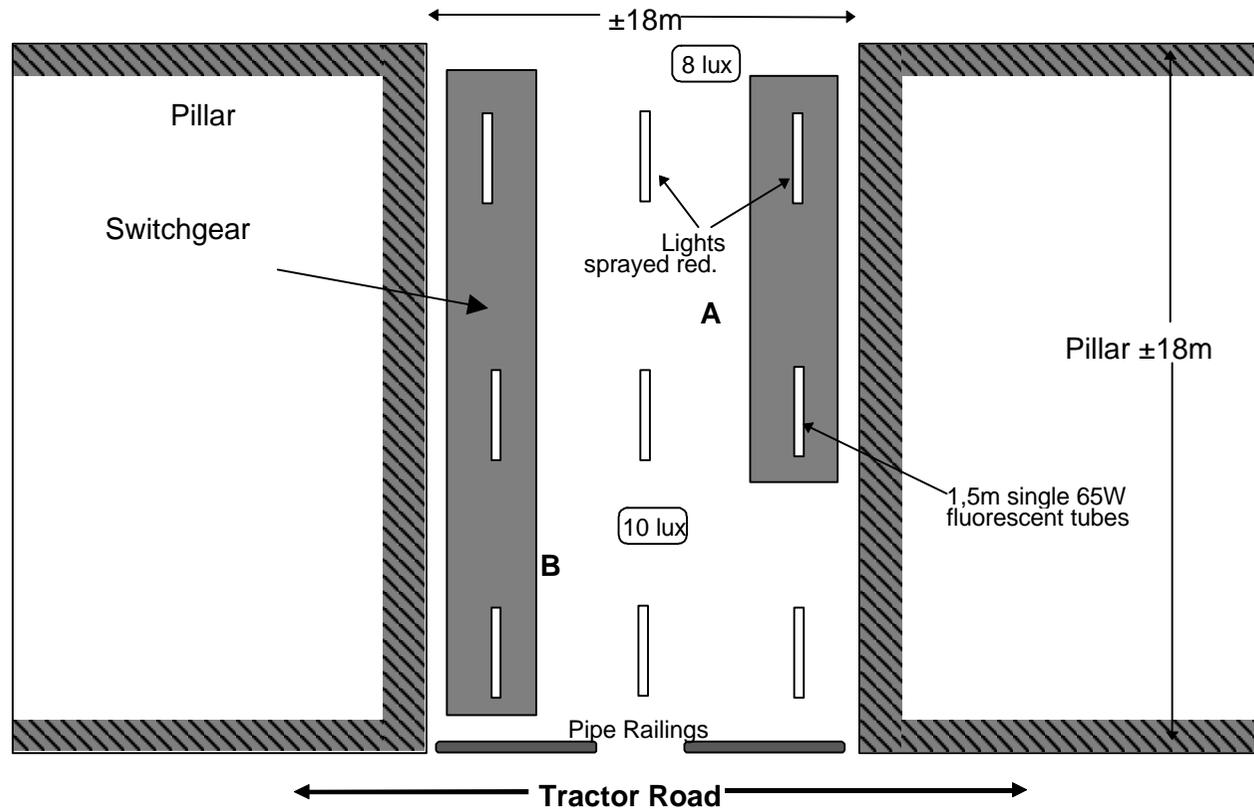
### ***Sub-station 3***

Electricians complained that they were unable to see inside the electrical equipment. They were unable to simultaneously look and shine their caplamps through the narrow work openings.

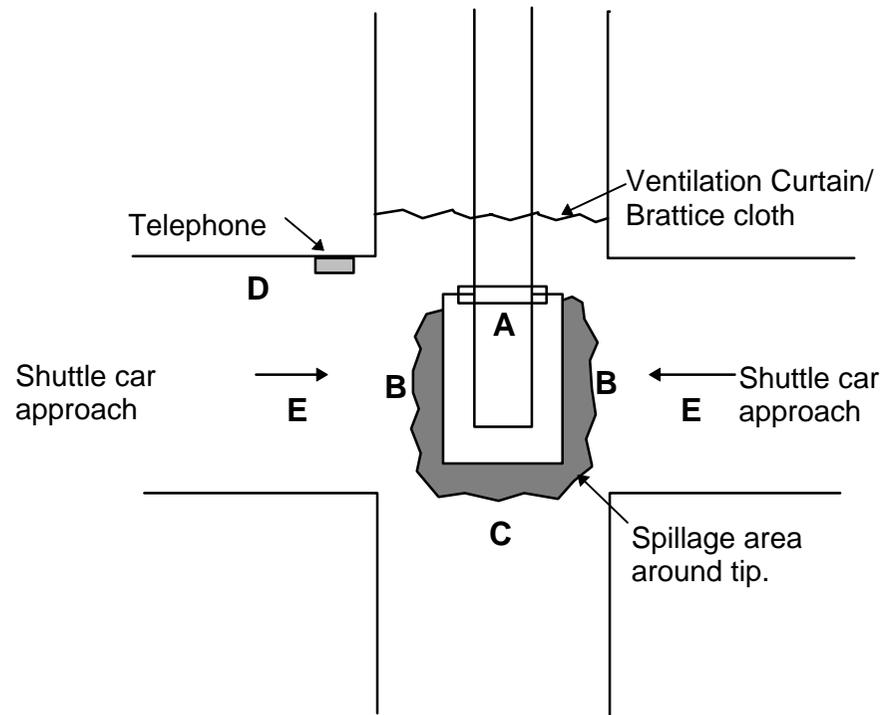
### ***Feeder Breaker***

Supply cables and obstacles were submerged in mud.

The single fluorescent light was covered in coal dust.

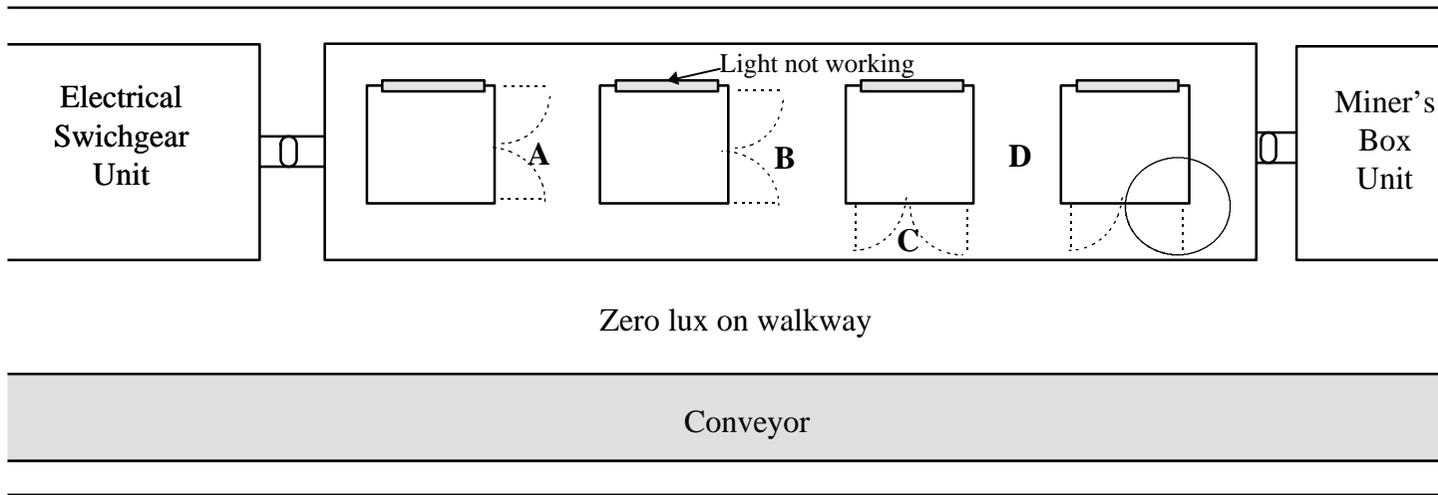
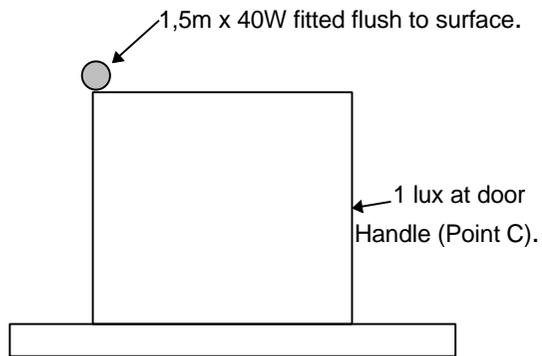
Miner's Box, Electrical Switchgear and Toolboxes at Location 3.

Note the reason for the 40 lux at point D was that the lights were mounted close to the ends of the two boxes as indicated in the side view diagram, and both lights were working.

The lights were installed on the wall side of where the unit was located on top of the toolboxes. As a result the light obscured by the toolboxes resulting in a zero reading in the walkway past these toolbox units.
