Safety in Mines Research Advisory Committee

Final Project Report

Best Practice: Conveyor Belt Systems

Project number: GEN 701

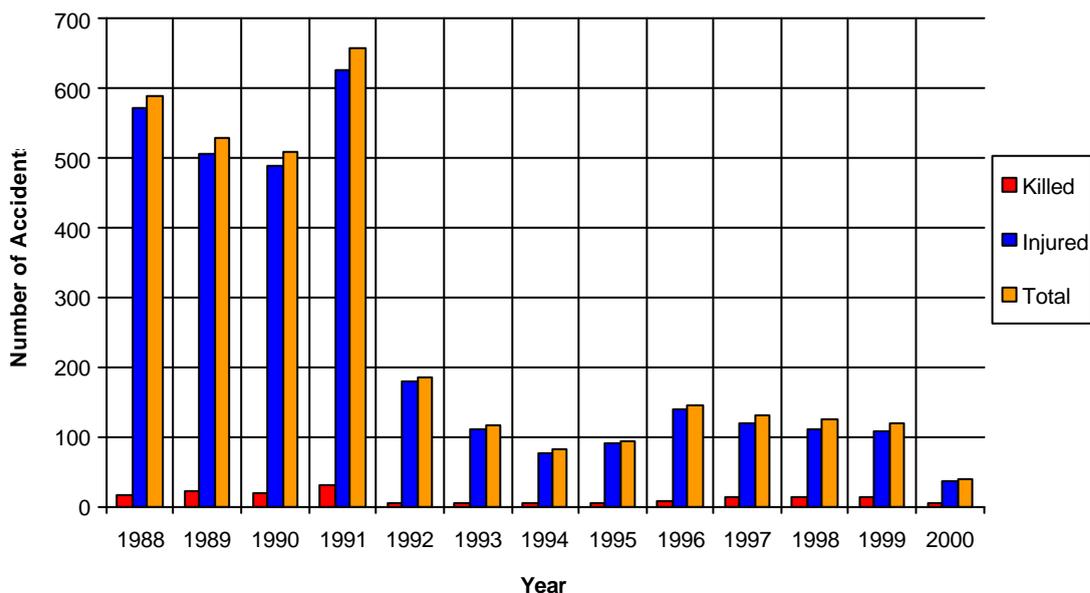
Figure 1: Conveyor accidents recorded in the SA mining industry (1988 – 1999)

The DME records regarding conveyor accidents in the SA mining industry for the period 1988-1999 can be summarised as shown in figure 1.

Figure 1 reveals conveyor related accident numbers of approximately 500 to 600 per year during the years 1988 to 1991. Since 1992 it has decreased to below 200 accidents per year and reached a low of approximately 80 accidents in 1994. However, during the period 1996 to 1999 it exceeded the 200 accidents per year level again.

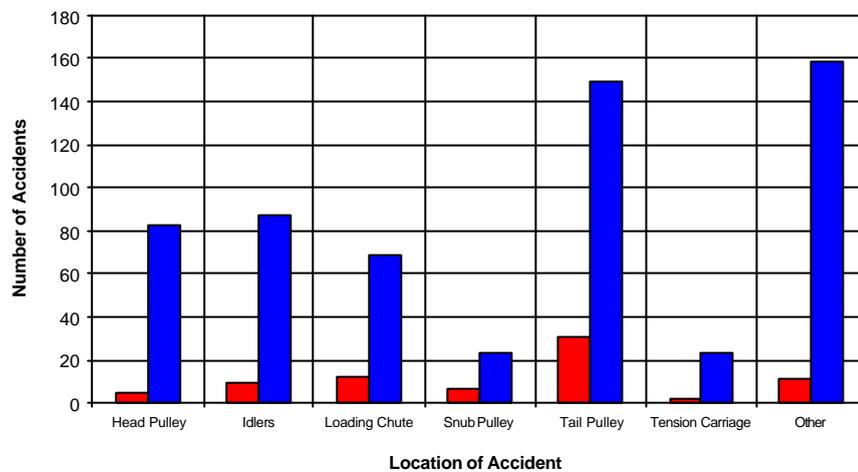
Figure 2: Accidents traceable to specific conveyor sub-systems (1995-1999)

Another source of useful information is an improved description added to the DME database since 1995. It describes the specific conveyor subsystem where the accident occurred as shown in figure 2. It is interesting to note that the tail pulley causes most fatalities while injuries frequently result from people working at the

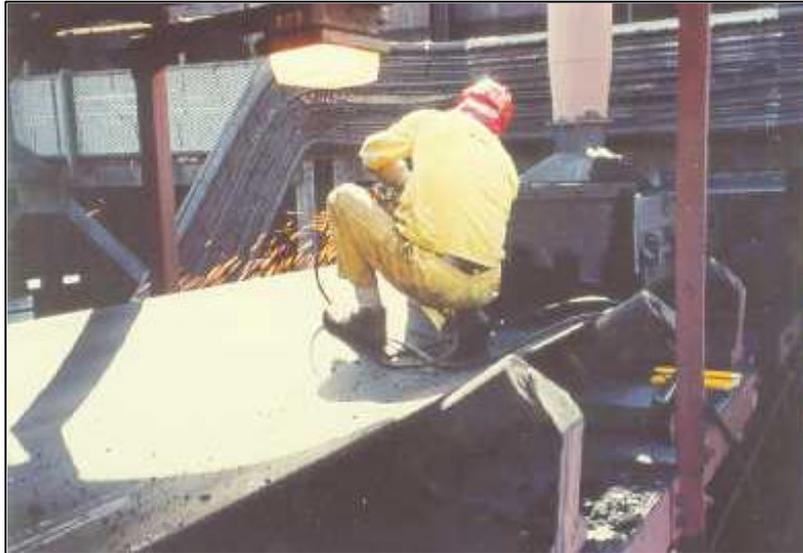
Figure 3: Man on conveyor belt performing maintenance after locking out

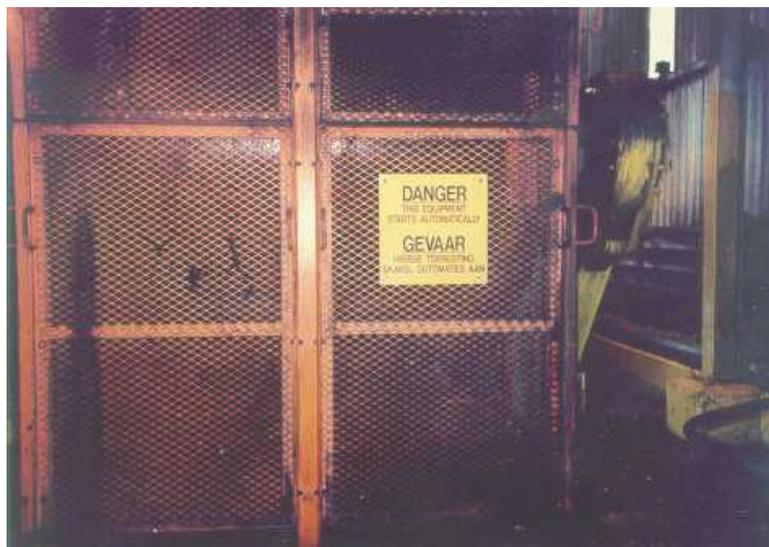
Figure 4: Effective guarding around drive pulley

Workers should be trained and encouraged to take greater care. Figure 4 shows an example of effective guarding with the appropriate warning signs. Applicable references are DIN 15220 and AS 1755-2000.

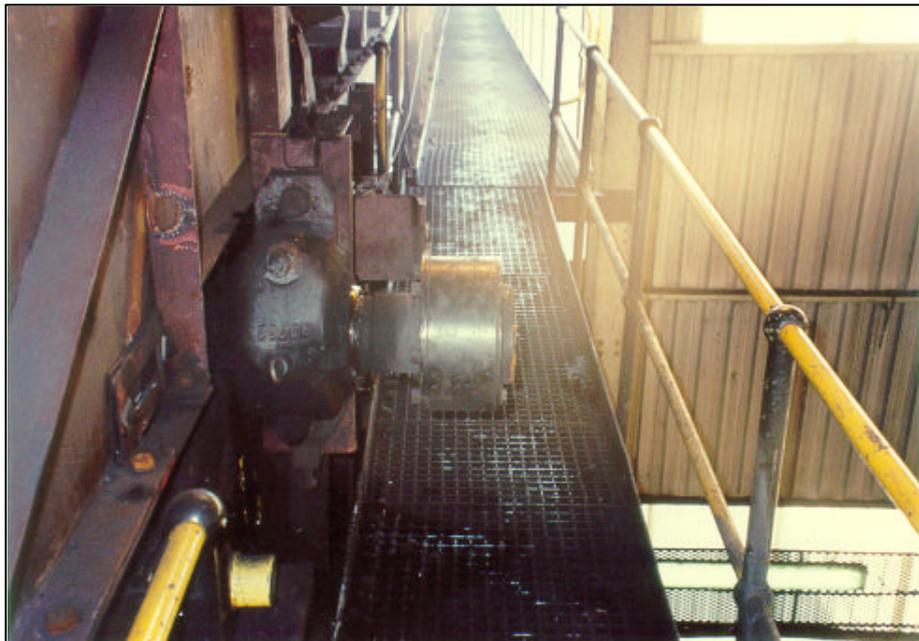
Figure 5: Walkway with restricted access

Equipment requiring maintenance should be allowed adequate access. This will prevent workers having to squeeze past rotating equipment in order to gain access to maintenance zones. General access may also become a problem as is shown in figure 5. Adequate access should be designed into the system to allow freedom of movement around the conveyor.

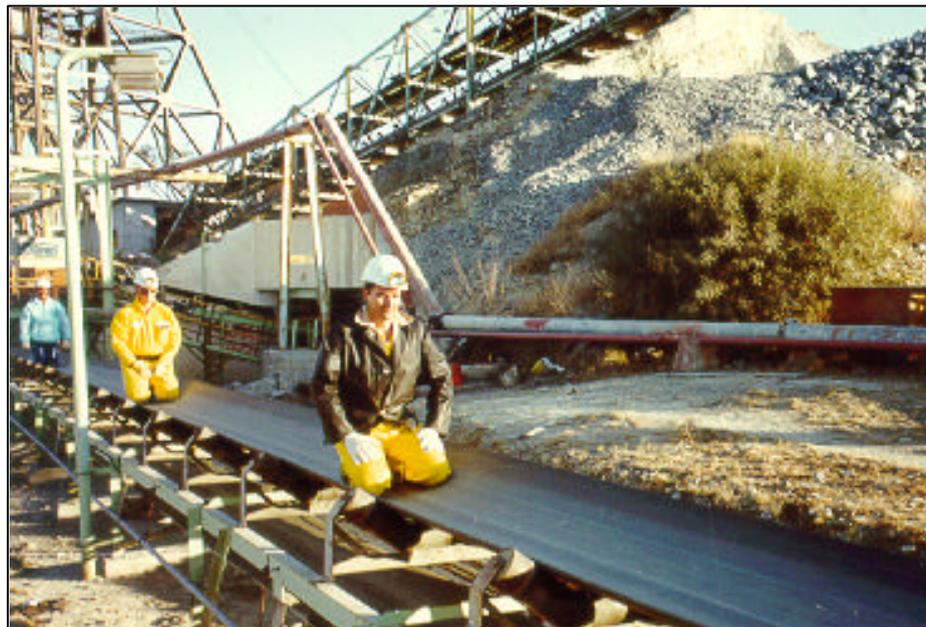
Figure 6: Training belt for man-riding

Every installation where man-riding belts are installed must have a training facility where visitors and new employees can undergo training by a skilled training officer, before going onto the actual man-riding conveyor. This training facility should preferably be on an incline and must allow for riding both carry and return strand. The training conveyor should also be variable speed, allowing trainees to at first board and alight at a slower speed. Figure 6 shows visitors undergoing training at the training facility before going underground. The more accurately the training facility simulates the actual environment i.e. belt speed, station layout et cetera, the more the benefit to be reaped from it.

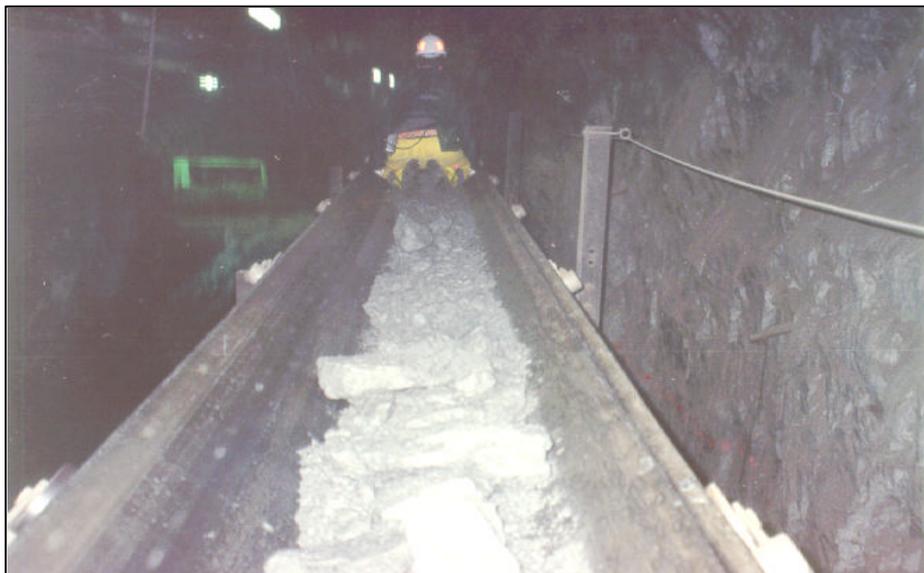
Figure 7: Man riding with material on conveyor

The danger involved is that the worker may get injured during boarding or alighting while attempting to ride the conveyor while there is material on the belt. The biggest danger is that workers may stumble over material or may slip on loose material on the belt during alighting. As can be seen from Figure 7, riding with material is accepted practice in the mines, though not recommended by SABS 0266.
