# **Appendix A**

## **Summary of Results from Field Studies**

# **MOBILE MACHINES**

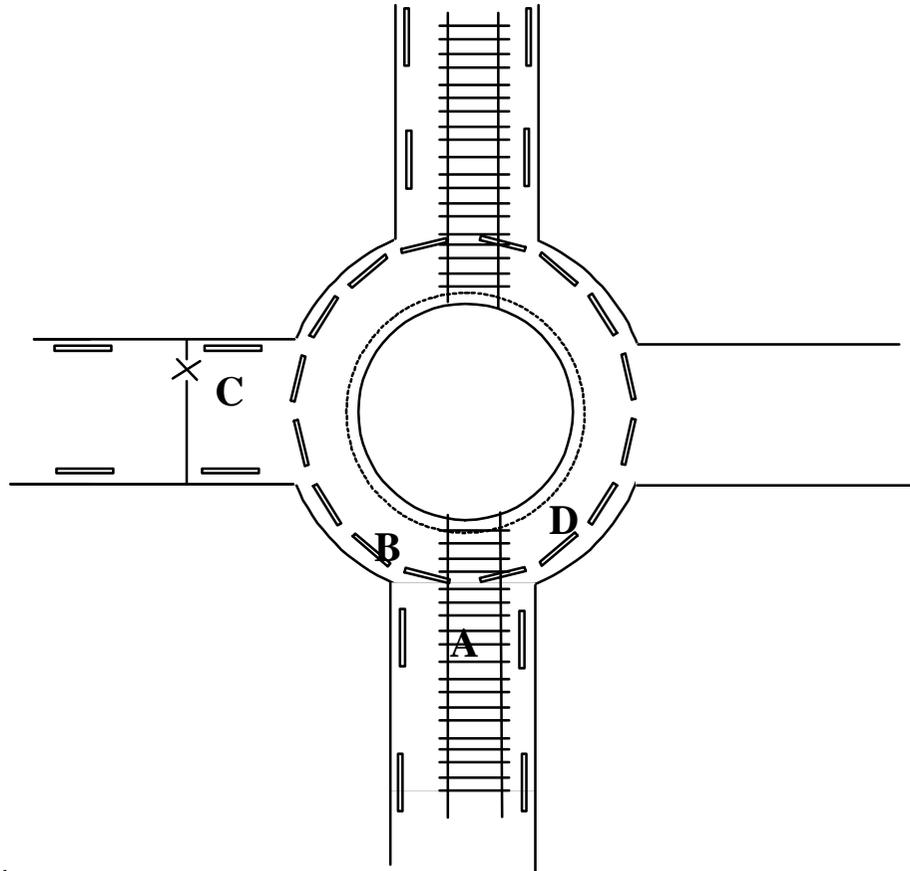
***Shaft Bottom Area 2.***

No visual limitations were identified that were likely to contribute to the risks arising from any of the inherent hazards that existed in the area.

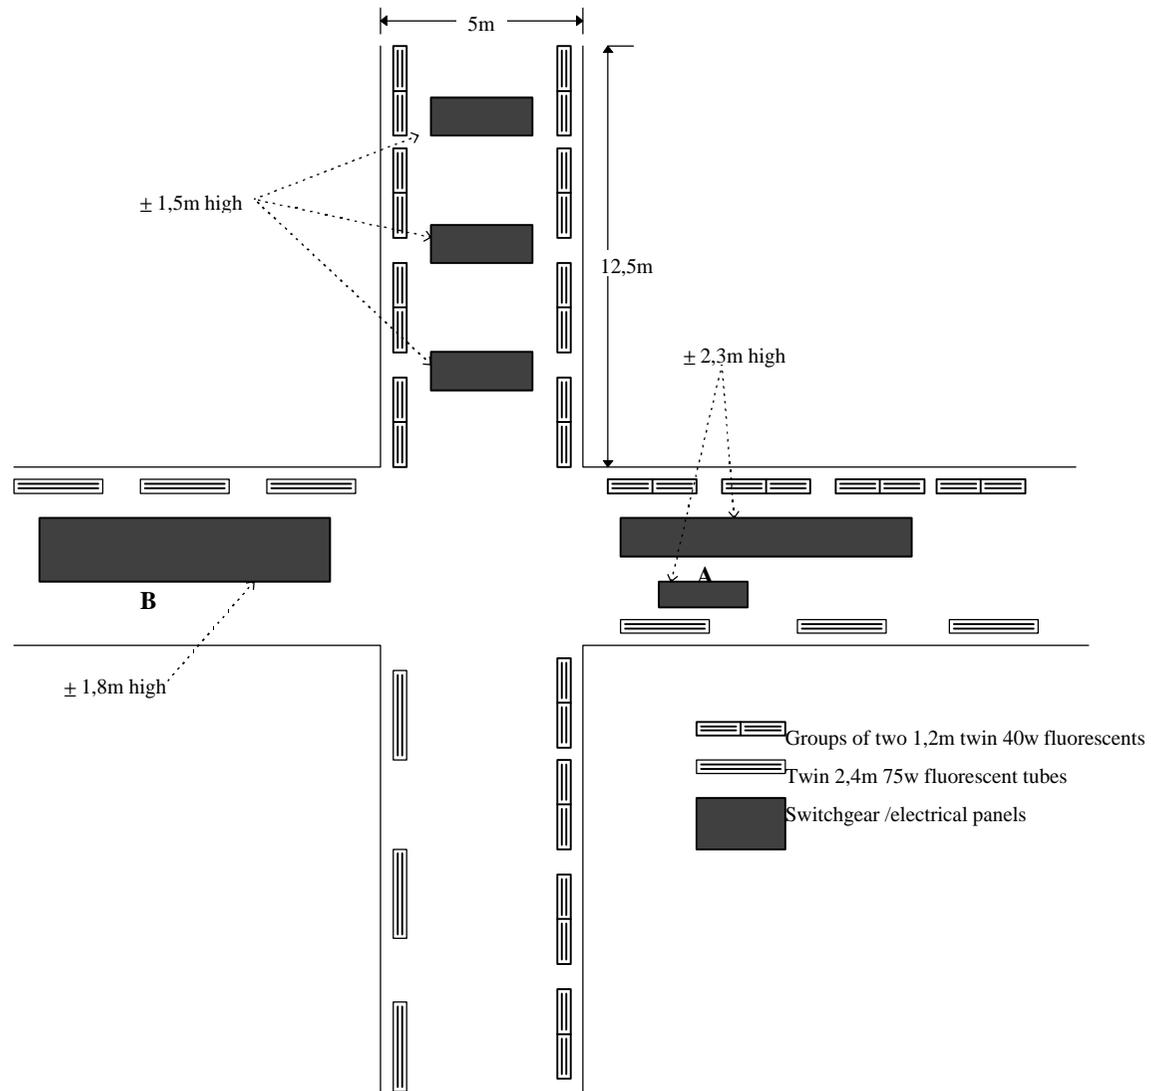
### ***Electrical Sub-station 1.***

Very good throughout the area. There were no sources of glare, areas of deep shadows or blind spots that were likely to have safety implications

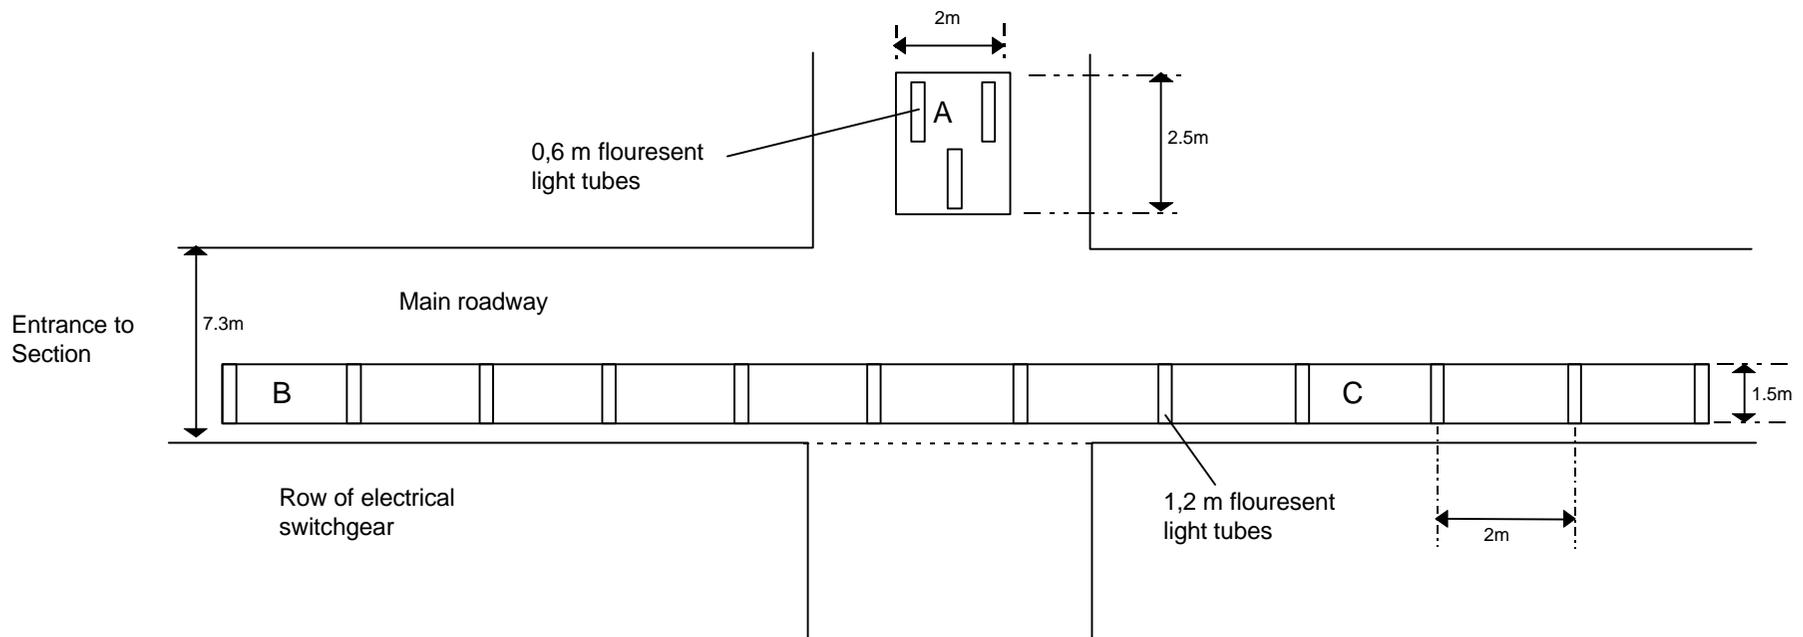
***Miner's box, Waiting Area and Electrical Switch Gear at Entrance to Section***

Good. Ground clear of obstructions; no slip/trip/fall hazards; light maintenance work undertaken on bench and to switchgear should not be compromised by any visual limitations.

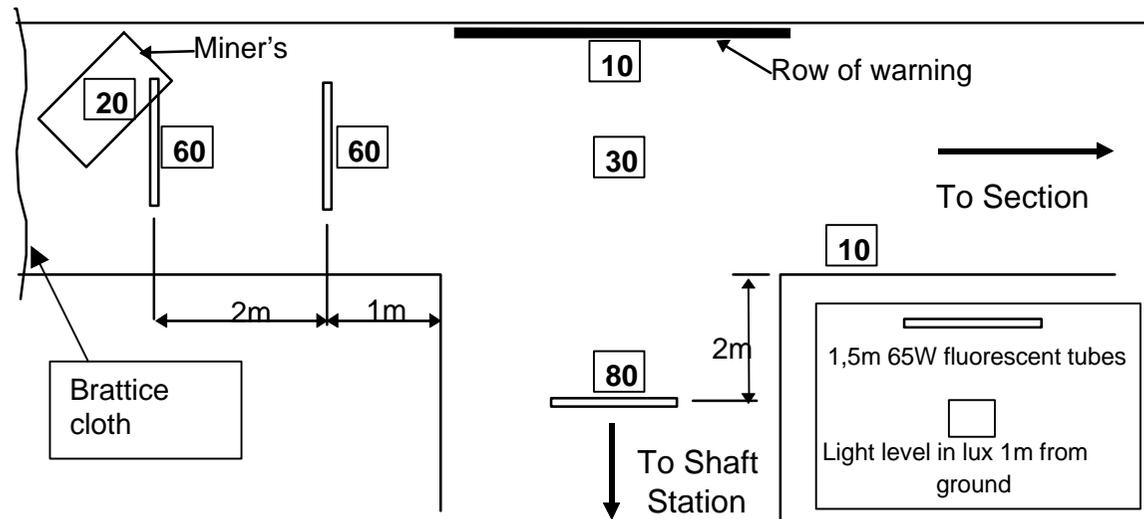
Miners Box and Waiting Area at Location 2.

Good. Ground clear of obstructions, no slip/trip/fall hazards. Safety should be not compromised by visual limitations.
